# PROCEEDINGS OF 5<sup>TH</sup> INTERNATIONAL CONGRESS OF SPELEOLOGY IN ARTIFICIAL CAVITIES

# Losing the Past: *Maps and Inventories of Cappadocia (Turkey)*

**Ali Yamaç**

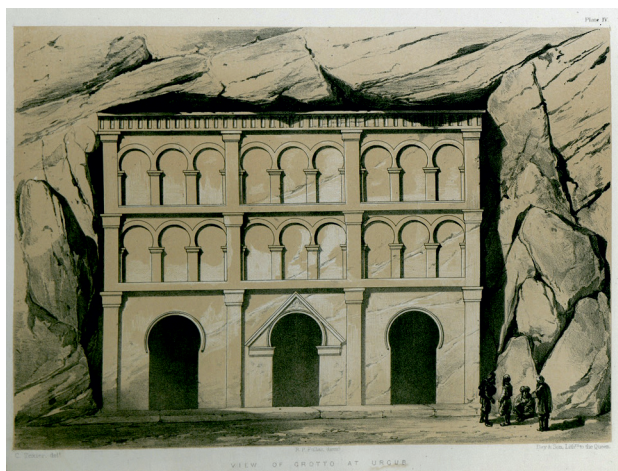
Fig. 2. Engraving by Texier showing the facade of a rock-cut structure (Texier 1839)

The facade of a rock-cut structure depicted in a 1839 engraving by Texier does not exist today (Fig. 2). The powerful monumentality expressed by Texier's facade seems to manifest capabilities beyond the grasp of Cappadocia's carvers. Various aspects of its design and decoration, however, strongly resemble features found in a combination of other surviving facades in Cappadocia. The drawing, therefore, probably documented an actual structure that by now has disappeared. Texier's elusive facade may well belong to the Bezirhane courtyard complex at Avcılar, near Ürgüp in eastern Cappadocia. The original courtyard facade of this complex has collapsed, so that the interior wall of the hall that rested directly behind it is visible as the complex's exterior. Much like Texier's facade, this surviving wall at Bezirhane exhibits three equally spaced bays framed by engaged piers and horizontal mouldings. In addition, the three horseshoe arches at Bezirhane are articulated in the same manner as those on Texier's facade (Texier

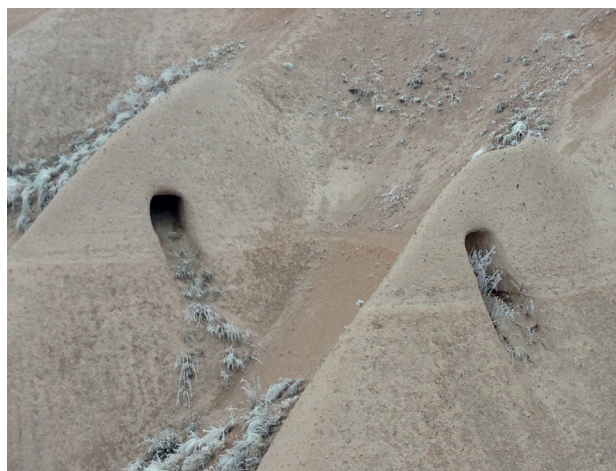
Fig. 3. Remains of an eroded water tunnel on the east wall of Güvercinlik Valley (photo E. Gilli)

Aqueduct remains excavated in valleys and lost their function over time due to erosion are another example (Gilli & Yamaç 2015). In Güvercinlik Valley there are several water tunnels portions, dug in the valley at different times, can be seen together. Despite many processes of maintenance and restoration, it is certain that ignimbrites are sensitive to erosion, thus the tunnels become unusable after a period of time (Bicchi et al. 1995). On the north part of the valley, another water tunnel is located on the opposite wall of main water tunnel. Remainings of that other tunnel which can be observed in places, have almost been vanishing completely because of erosion. A small part of it, which is older than the main tunnel and where there are subsidiaries of previous water tunnel located also on the east wall, has been explored and surveyed. South of this area, it is mostly certain that the holes observed on the completely eroded east walls of the valley belong to another water tunnel (Fig. 3). Similar eroded holes also exist in Meskendir Valley (Castellani 2002).

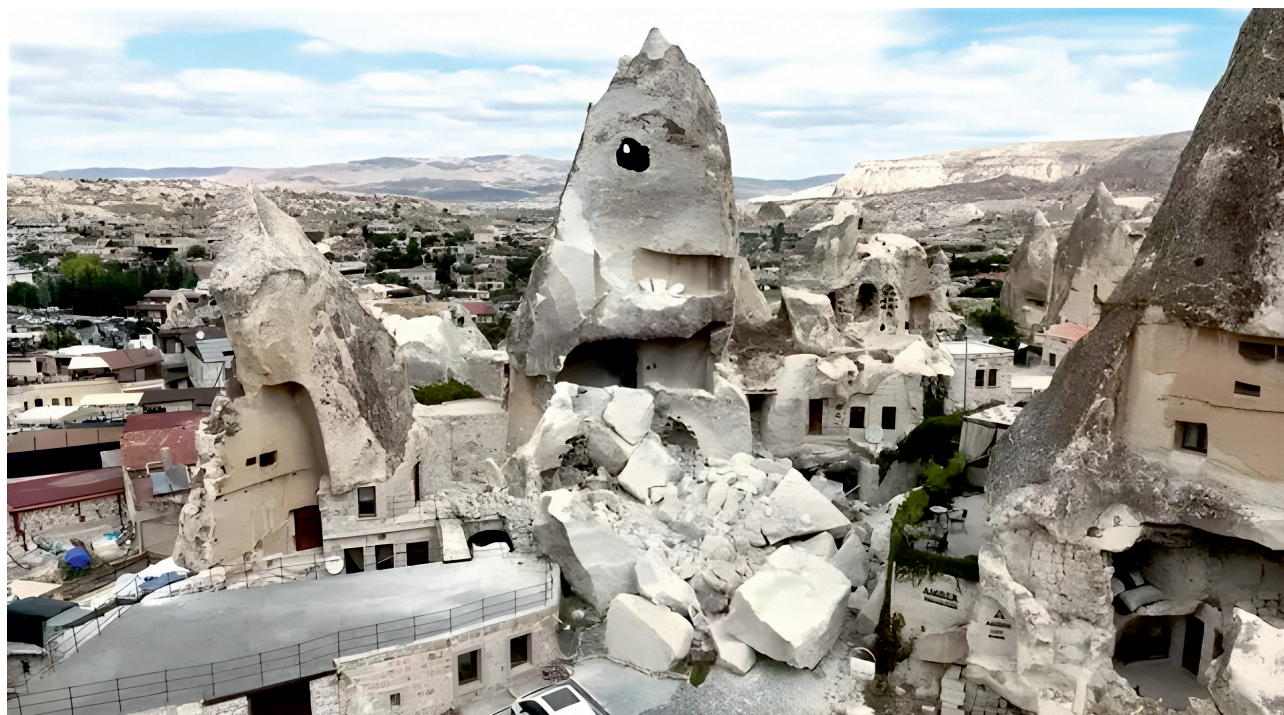
Fig. 5. Göreme, collapse of a fairy chimney at Sept. 20, 2025 (photo Anadolu Ajansı)

A few months ago, two major collapses occurred in Göreme and Ürgüp, destroying dozens of dwellings that had not yet been explored or surveyed (Fig. 5).
